Report of Results: MVAXXXX

Identification of Material on Filter

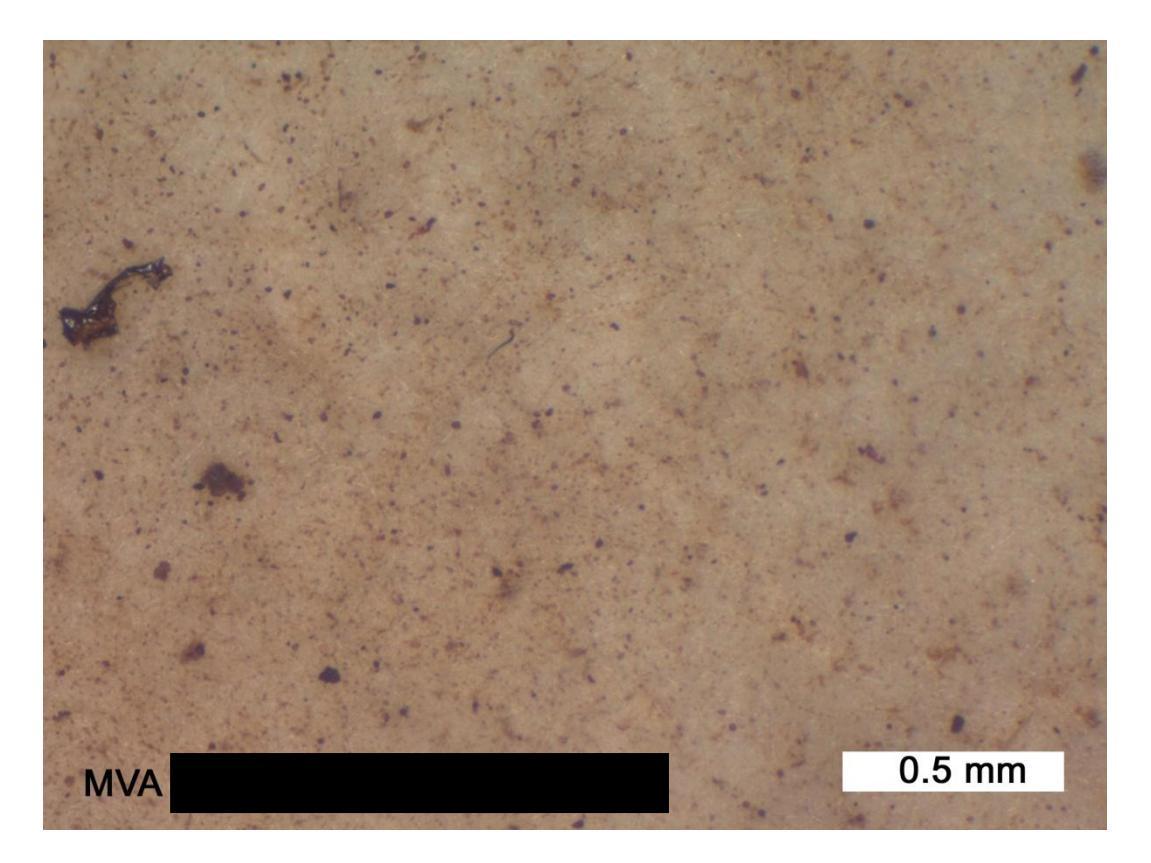
Figure 1. Stereomicroscope image of residue and glassy material on filter XXXXX.

This sample presented as a light brown encrustation on a quartz fiber filter with some relatively large darker particles resting on the filter surface. Visual estimates via stereomicroscope along with SEM/EDS data indicate that the vast majority (~80%) of the material present on the filter consists of relatively small brown beads that presumably collected on the filter as liquid with a much smaller amount of larger black opaque particles present on the filter surface (Figure 1).

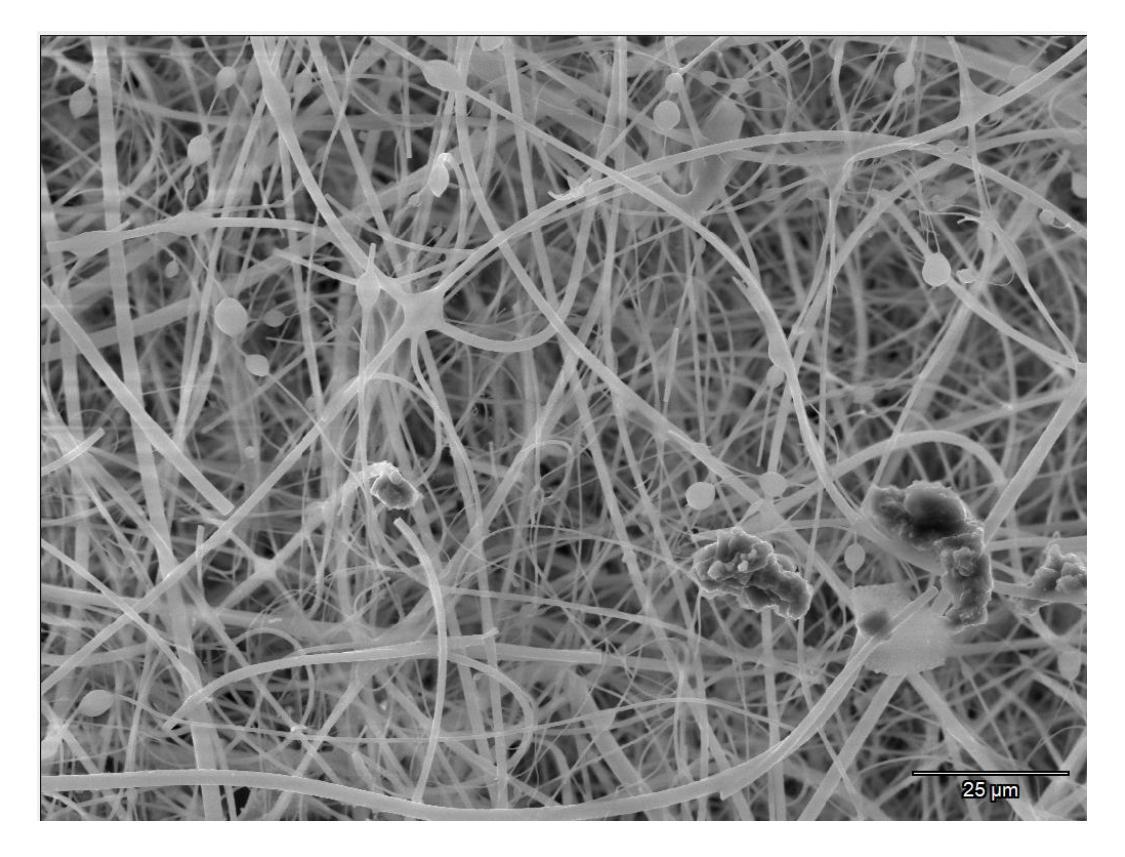
Figure 2. SEM/EDS image of liquid beads in sample XXXXX.

SEM/EDS analysis (Figures 2 and 3) indicates that the beads are carbon-rich with some small nitrogen component. SEM/EDS analysis shows the larger particles are a carbon-rich brittle material containing smaller amounts of sodium, magnesium, aluminum, calcium, sulfur, and iron (Figures 4 and 5) and particles consistent with iron/steel corrosion (Figures 6 and 7).

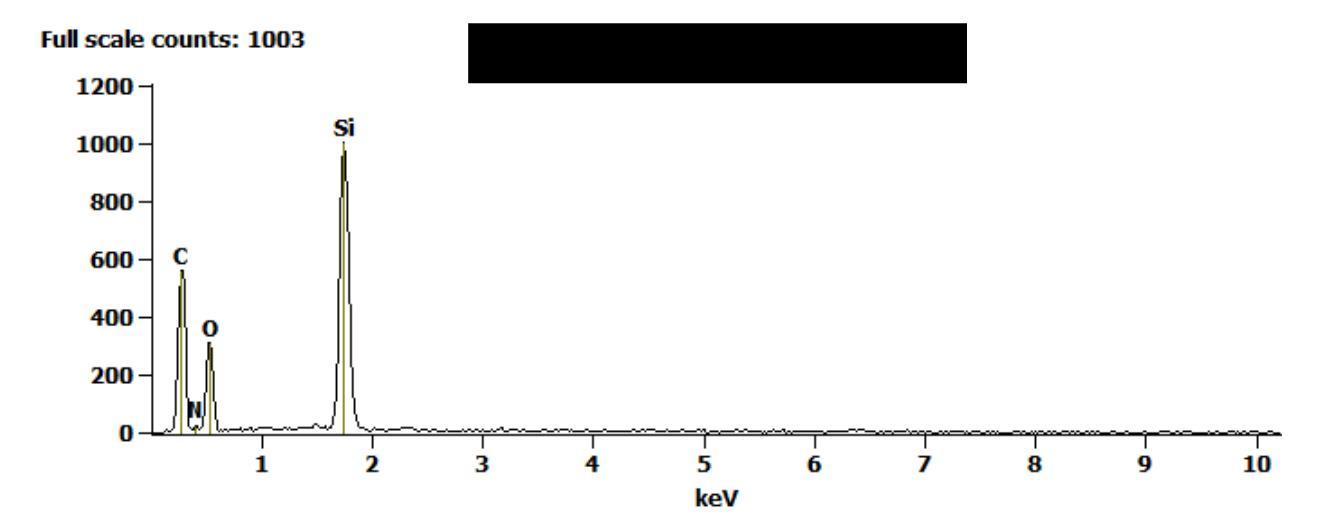
Figure 3. EDS spectrum from Figure 2. Example of bead on quartz fiber filter. C = carbon, N = nitrogen, O = oxygen, Si = silicon.Silicon peak can be attributed to the quartz fiber substrate.

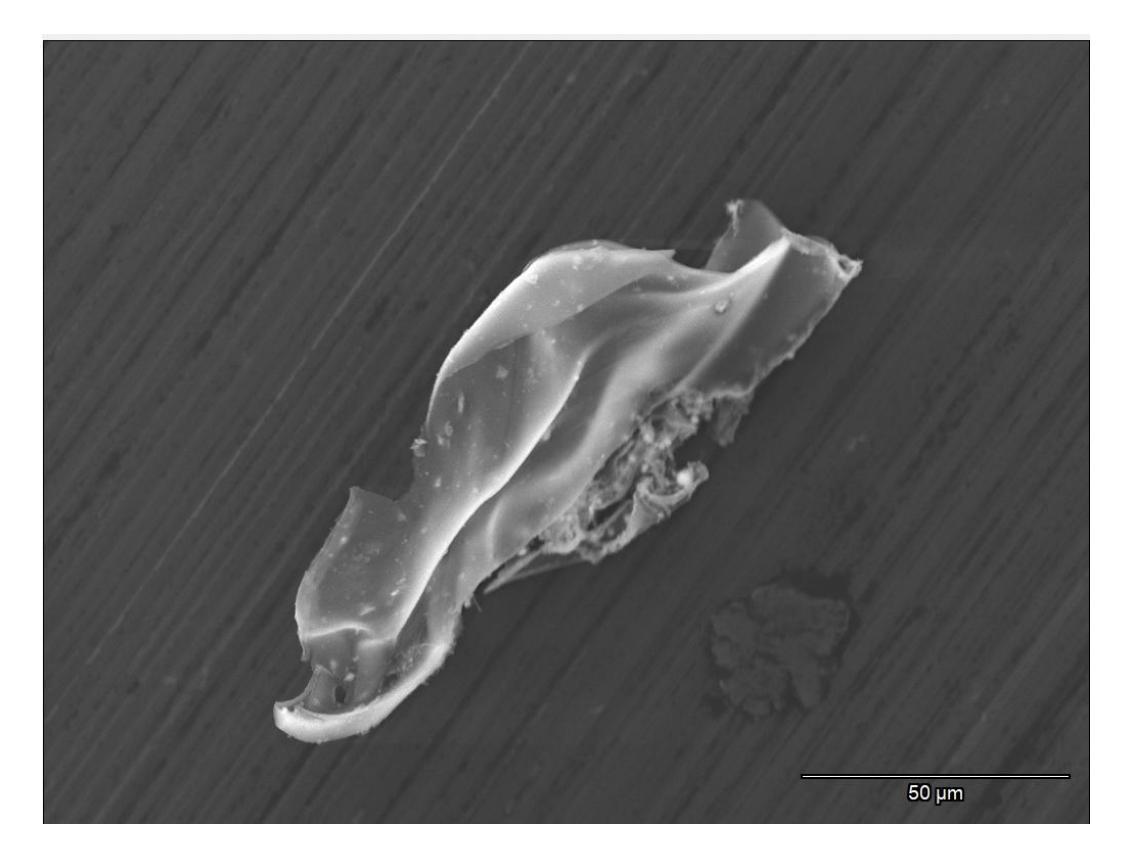
Figure 4. SEM/EDS image of carbon-rich brittle particle in sample XXXXX.

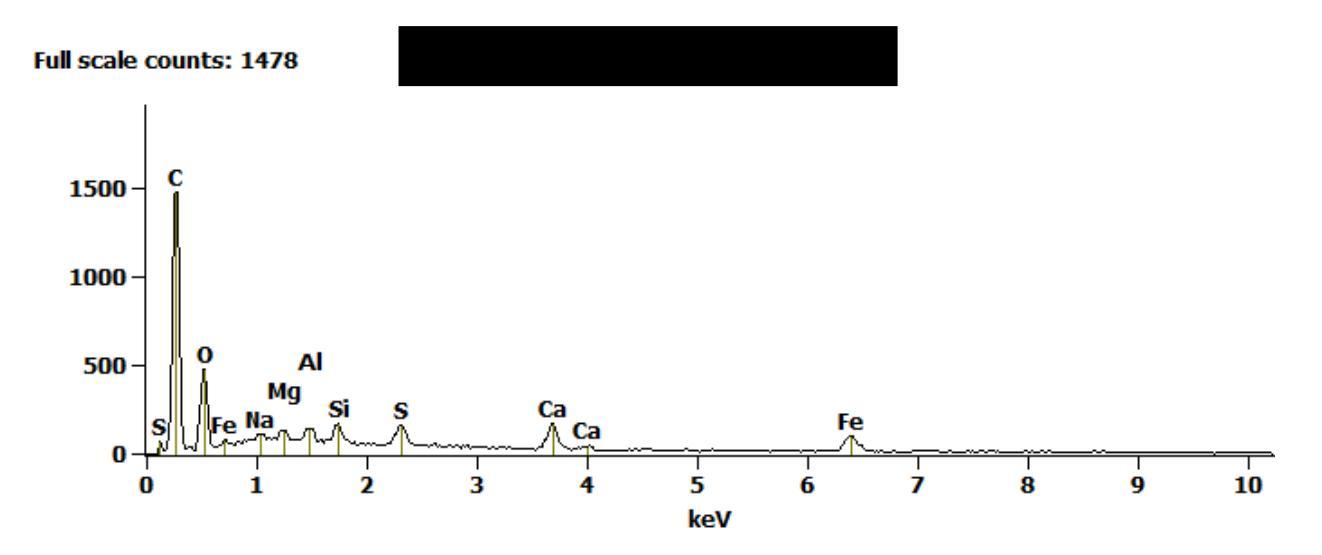
Figure 5. EDS spectrum from Figure 4. Example of carbon-rich particle. Na = sodium, Mg = magnesium, AI = aluminum, S = sulfur, Ca = calcium, Fe = iron.

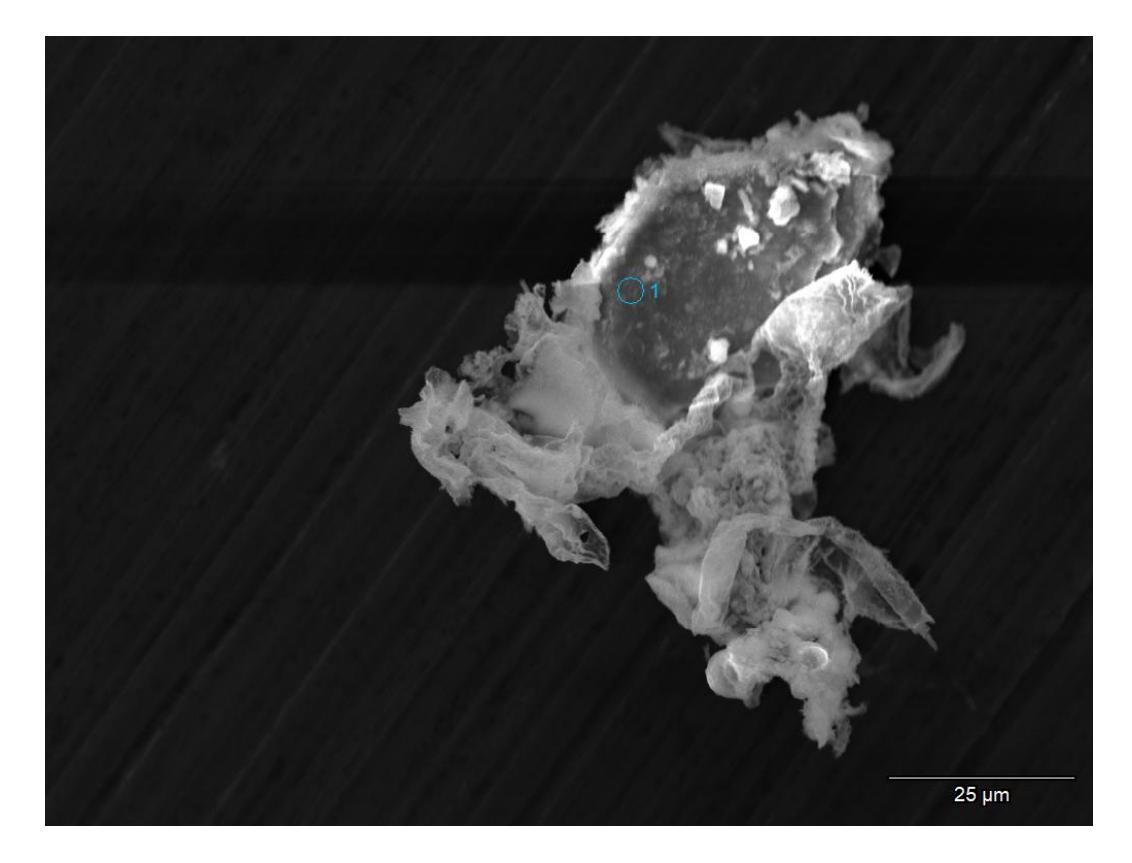
Figure 6. SEM/EDS image of corrosion flake in glassy particle in sample XXXXX.

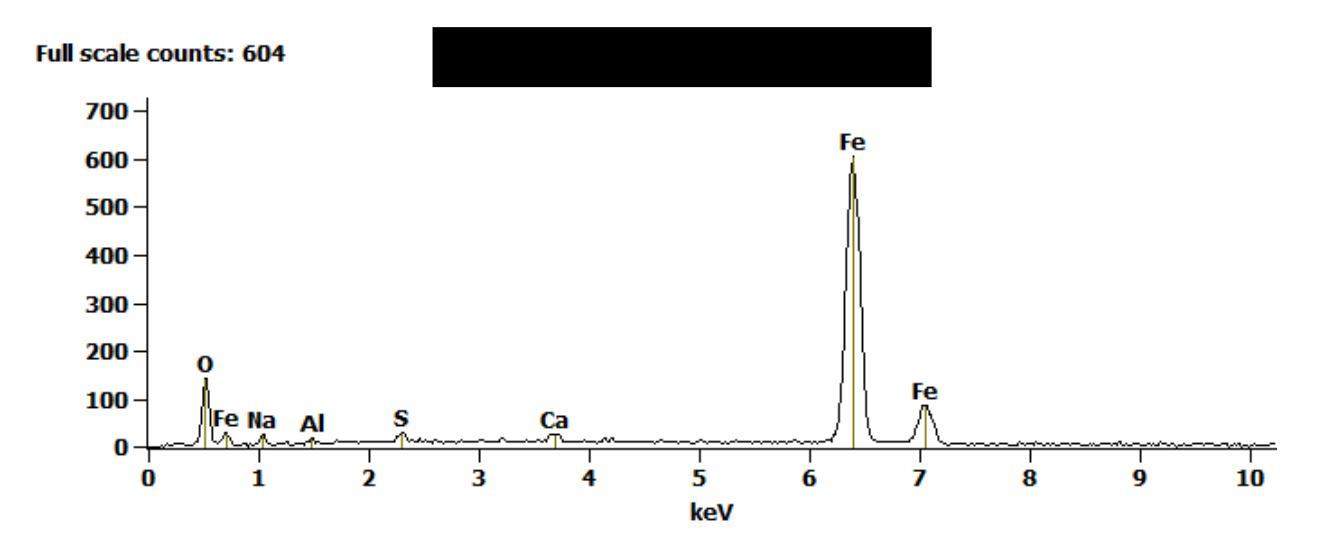
Figure 7. EDS spectrum of area 1 from Figure 6. Example of iron corrosion particle.

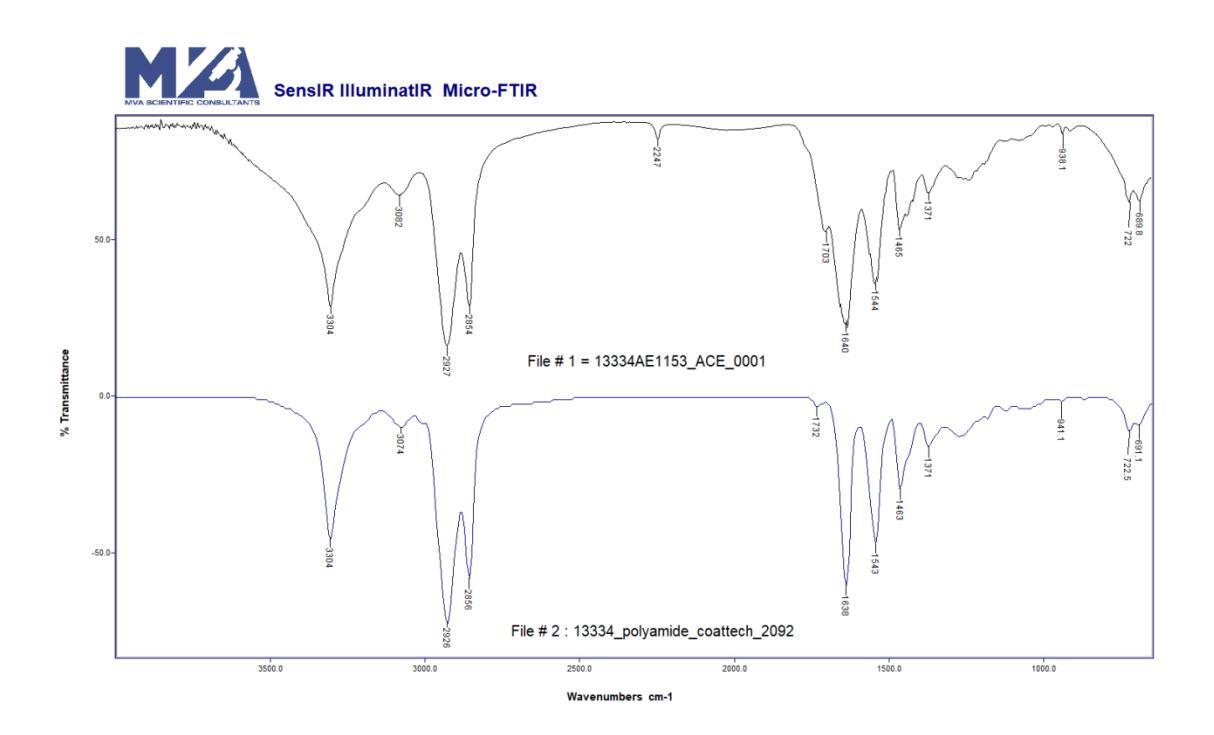
Figure 8. Sample XXXXX. The infrared absorption spectrum obtained from an acetone extract of the bulk sample (upper trace) shown with a reference spectrum for polyamide (lower trace).

Acetone extraction of a portion of the filter yielded material with an infrared absorption spectrum consistent with a polyamide material (Figure 8).
